NRL/MR/7440--02-8280

Demonstrating a Moving-Map System With Electronic Charts for Improved Lane Navigation: Testing on AAVs in Gulfport, MS

*Mapping, Charting, and Geodesy Branch
Marine Geosciences Division*

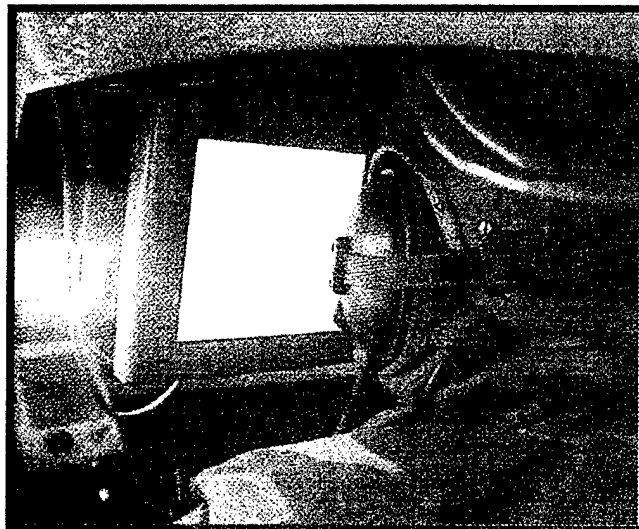
Figure 4. An AAV driver using the MM system during testing in Gulfport, MS.

Figure 4 shows the driver and map display during the actual test in Gulfport. A second, smaller display was installed in the turret for the Crew Chief that showed the same view. PFPS gives the ability to zoom the map display in or out so, it could be adjusted to accommodate viewing preferences.

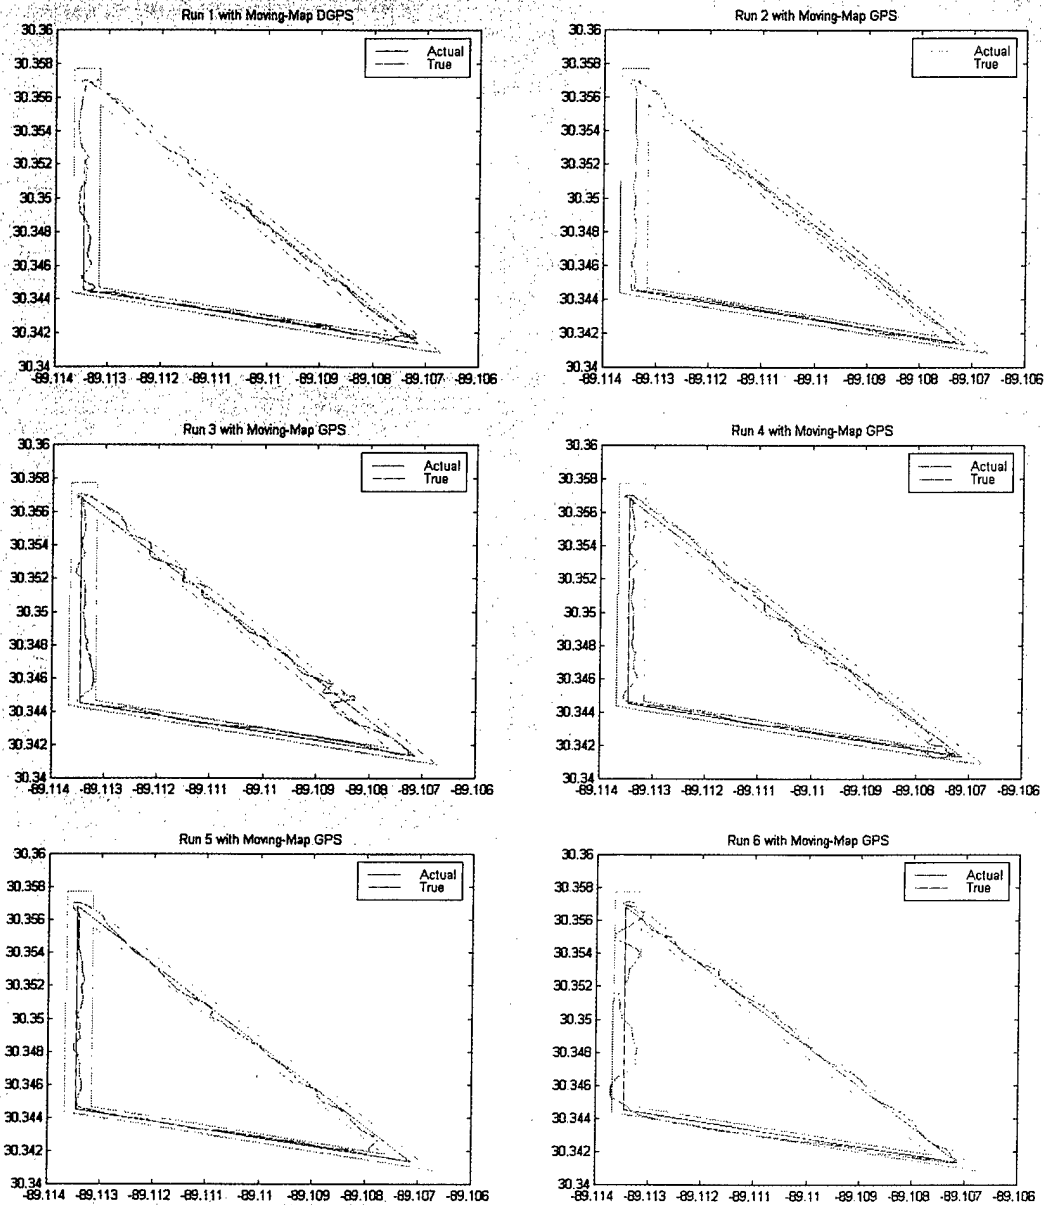
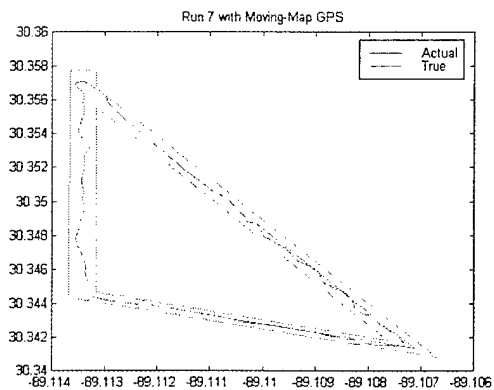
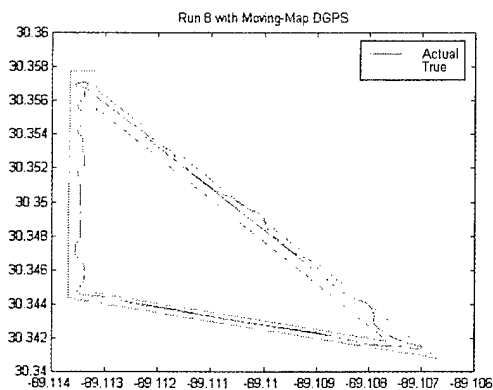
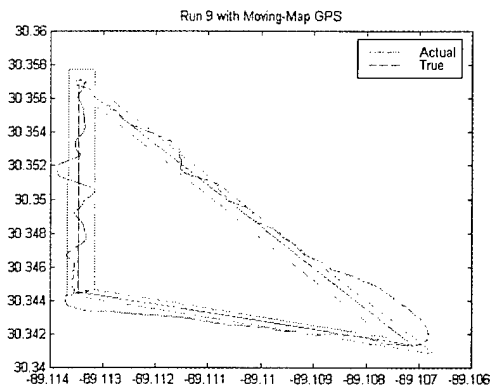
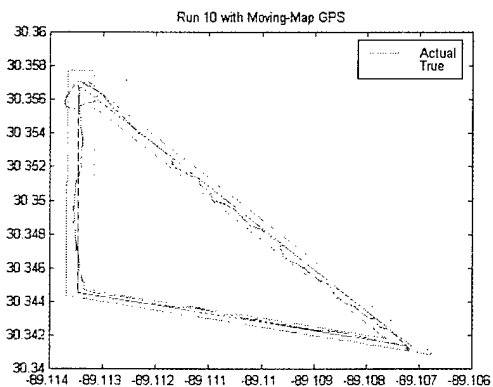
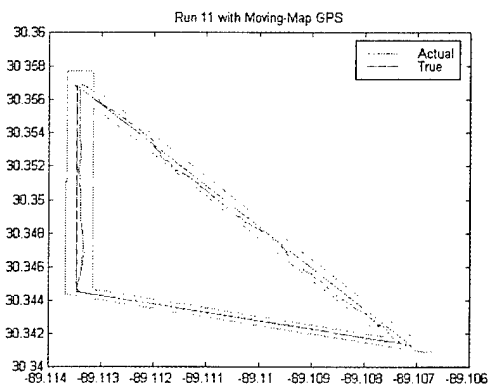
APPENDIX B

Plots showing actual versus true navigational coordinates for all test runs. Within each plot, a green line is used to outline the entire 50-yard width of navigation lane, the lane center is drawn in blue, and the AAV track is drawn in red. The beach was located in the northwest portion away from the plot
